Service Note

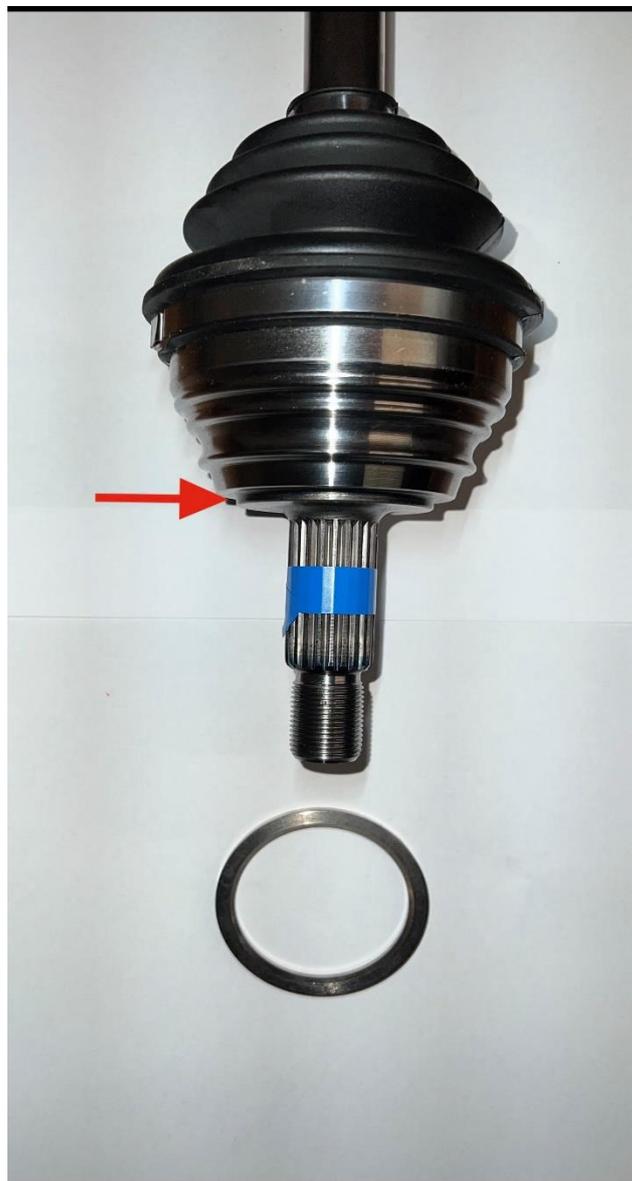
Cars fitted with billet aluminium uprights, it's very important when replacing drive shafts or dummy flanges the Adaption Ring must be refitted.
