SERVICE NOTE No. 2/2014

Date of issue 24/02/2014

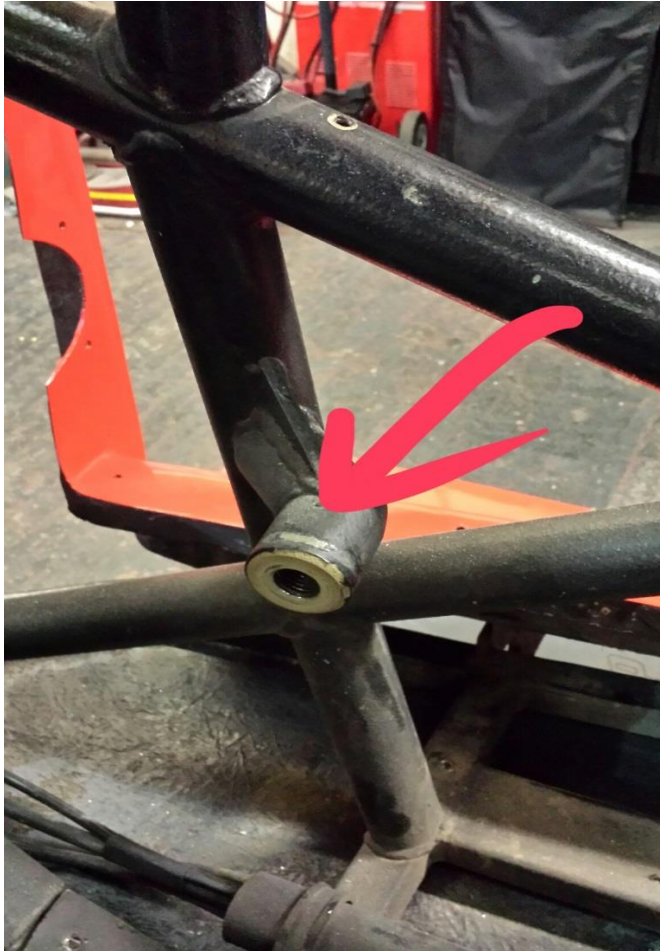
Please inspect the condition of the gear lever mounting bracket, we have seen this bracket fail and break off the chassis since the introduction of the sequential gearbox. Weld and brace if required and inspect on a regular basis.
