# Fun Cup UK

## ! SERVICE NOTE !

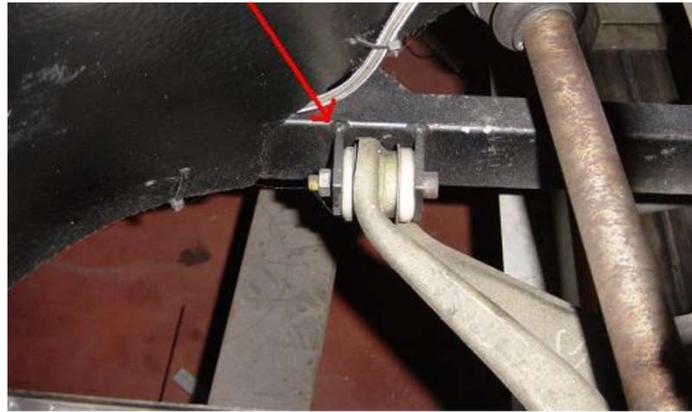
we have found that the welds on the rear wishbone tabs have cracked  
please check these welds

If cracks are found it is advised that you replace them with reinforced ones  
CH43G (left) and CH43D (right)

As a precaution we recommend you change these even if the weld looks good

If you change these yourself replace one by one and be sure to weld them in the correct place the  
correct spacing between the mounts is 44.3mm
