SERVICE NOTE

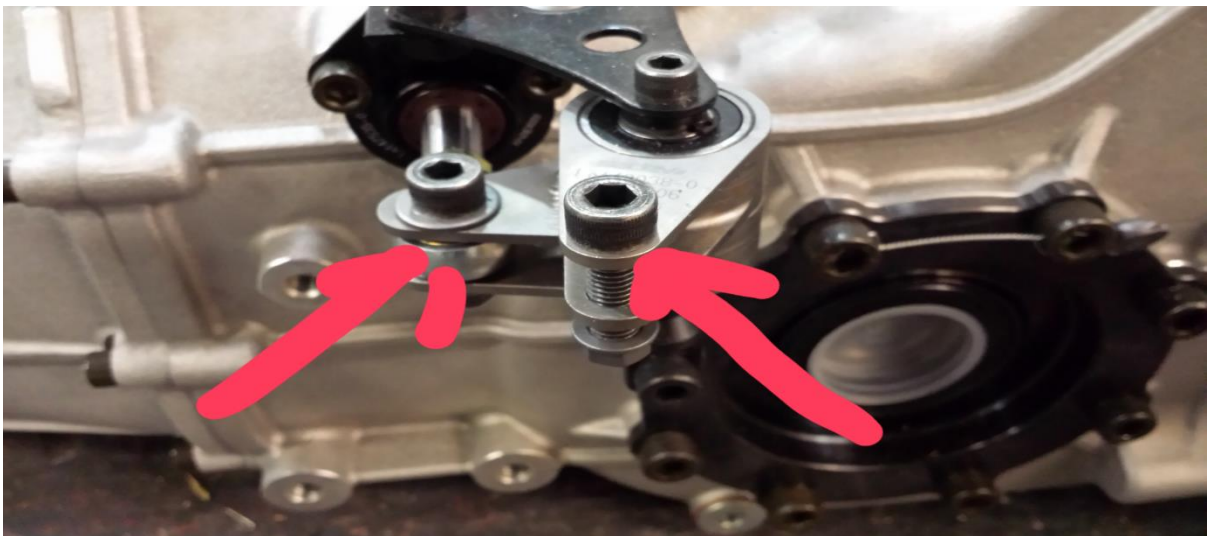
1. Before each event, it is recommended that you check the rose joints are completely free at either end of the gear linkage and the rose joint that bolts into the gearbox (3 in total) if in doubt, replace them. Also, please make sure that the bolts securing the rose joints are NOT tight. Please see picture:

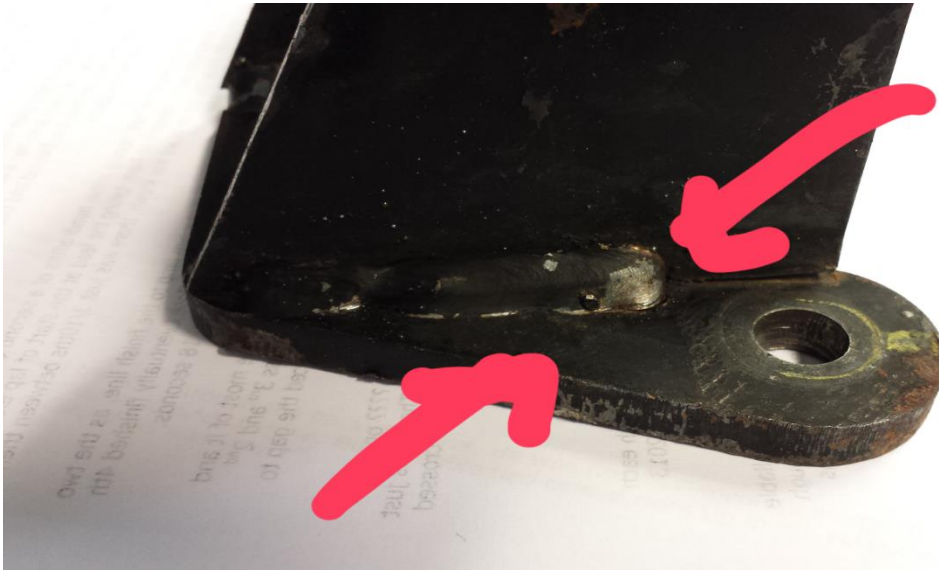
2. It is also recommended that you remove and inspect the right engine mounting, check for any signs of cracking, either replace or repair/strengthen as required. Please see picture:
